Paper Title: **Increasing Problems of Falling Ice and Snow on Modern Tall Buildings**

Author(s): Carter, Michael & Stangl, Roman

Original Publication: CTBUH Journal 2012 Issue IV

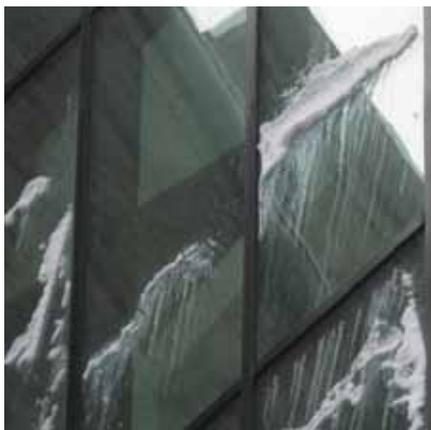
Figure 1. Example of snow and ice freezing on vision glass panel. © NMI

In this example (see Figure 1), observations of ice sheets were reported to form in the center of vertical vision glass of a recently completed building, and would subsequently release and fall to the busy street below. This report was taken with some skepticism as heat loss characteristics of a traditional window and frame relationship call for the exterior skin temperature of the center of the window to be the warmest location, since it is the furthest from the influence of the frame that would typically have the advantage of insulation or a thermally broken profile. However, in this particular case the large insulated glass panels offered an improved thermal performance over traditional glass and there was no spandrel panel, only a minimalistic metal frame. Thus, the glass panels were the main resistive component of the assembly, promoting ice to form directly in the center (the coldest location) of vertical vision glass panels. The key point to this example is the fact that the profile of the assembly is producing skin temperatures that align with exterior temperatures during more typical winter precipitation events, thereby promoting an increase in frequency and severity of icing over more traditional wall assemblies. To be clear, the relationship between glass and frame is not the sole

cause, but likely a tipping point for this particular example. Other influencing factors could include: the move to more efficient with under floor displacement ventilation systems, the heat loss characteristics of the whole façade as a system, and external factors such as elevation, building geometry and orientation to prevailing weather. Overall, this example reveals that as improvements in building performance are made, and exterior skin temperatures are reduced or at a minimum modified, there is opportunity for hazardous ice and snow formations to occur in different manners and amounts.

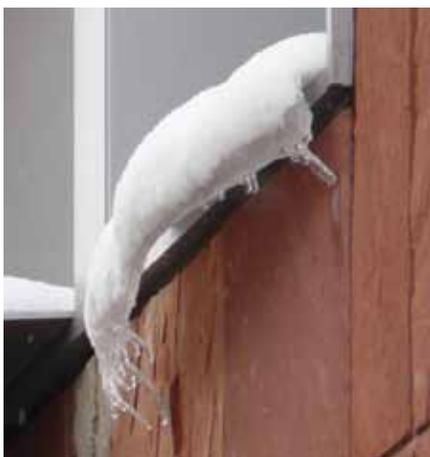
Figure 2. Example of hazardous ice formation on window sill. © NMI

The second example (see Figure 2) also deals with the relationship between glass and frame. However in this case the focus is on ice and snow formations that accumulate on window sills or mullion caps at the base of vision panels. In this example, significant ice formations were consistently forming at the edge of mullion caps and falling. Historically, sills or mullion caps of a relatively small dimension were not prone to hazardous ice formations, as heat loss through the curtain wall system would create sufficient melting to avoid significant ice formations. However,

again we note that as building performance improves, the exterior temperature of the building skin becomes colder, resulting in a change in the typical melting process of accumulated snow on the mullion cap. In this particular example, melting of windblown snow would occur on segments of the vision glass draining to the frame and sill below, as well as in the area of the frame and sill closest to the glazing panel, where heat loss could raise the skin temperature above freezing. The melted or slushy snow formations in these areas would then work their way to the outer edge of the sill and subsequently refreeze and eventually fall or be windblown. This condition is common on larger low-slope ledges. However as the thermal performance of the building façade improves the size of surfaces at the base of a glass panel that can create hazardous ice is getting smaller. Regarding this particular case, the façade has been tuned to generate ice during more common winter precipitation events.

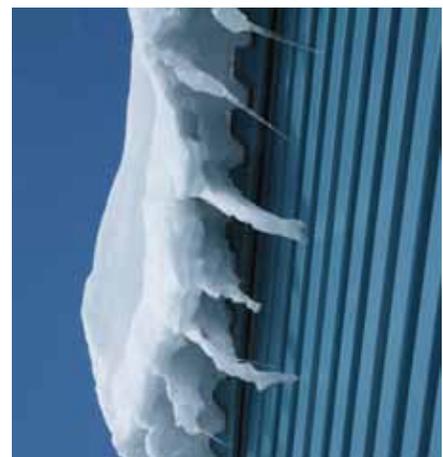
Figure 3. Example of hazardous ice formation on a ledge. © NMI

In this example (see Figure 3), a 20-year old tall building was reported to have experienced a severe falling ice event from approximately 137 meters above street level. The ice sheets were observed to form and then fall from a ledge situated near the top of the building. As this was the first reported incident of this magnitude, it was thought that an unusual

meteorological event or changes in the local micro climate due to the addition of other nearby tall buildings had caused the incident. However, the investigation could not directly link the incident to these variables. Upon further questioning of the building operations personnel, it was learned that the interior of the upper floors had recently been renovated to improve occupant comfort. The renovation included repairs to reduce air leakage and the addition of insulation to reduce heat loss. It was evident that the performance of the exterior façade at the top of the building had changed, causing ice buildup in areas that previously drained away as water. This meant that falling ice was likely to occur in most every winter storm, creating the need for an extensive and permanent falling ice and snow solution.

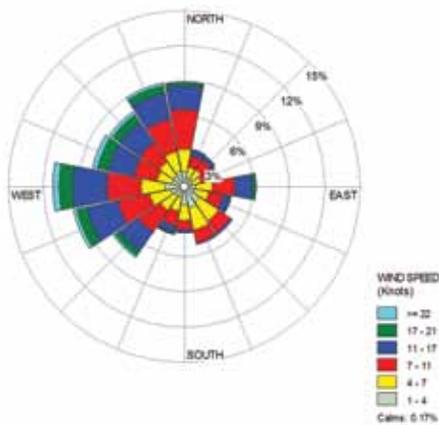
Figure 4. Example of a wind analysis demonstrating wind direction, speed and frequency for winter winds. © NMI

will reveal the frequency, directionality and severity of various types of winter storm events, such as freezing rain, wind drifted snow, heavy snowfall, in-cloud icing or freezing mist (see an example in Figure 4).

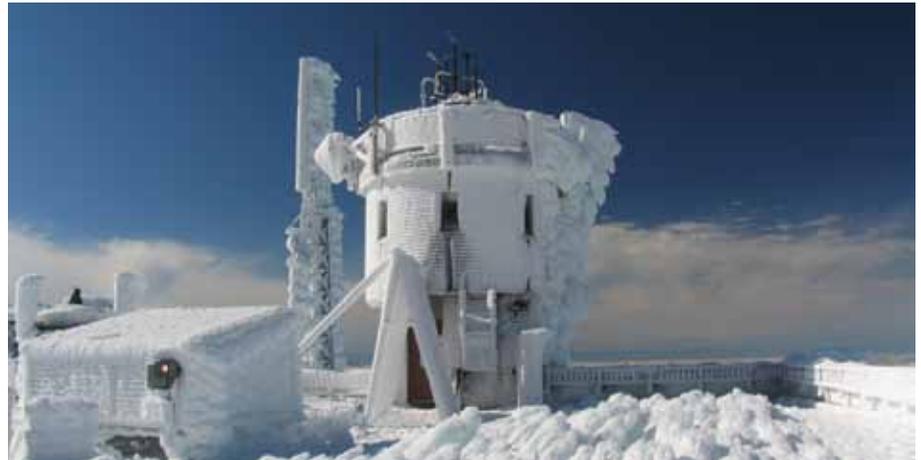
Figure 5. In-cloud/rime ice formations at the Mt. Washington Observatory. © Mt. Washington Observatory

For example, an often misunderstood event that impacts tall buildings in particular is the formation of high elevation in-cloud ice. This type of icing is also known as rime ice and is most often associated with aircraft wing icing. Similar icing formations are also associated with freezing mist and freezing fog formations when they occur with wind at lower elevations. Regular occurrences of this type of icing event has been reported on buildings and structures in major North American cities

such as Boston, Chicago, New York and Toronto; as well as other cities around the world. Tokyo Sky Tree recently received icing mitigation to address fears of snow and ice falling from the upper portion of the structure during the winter weather, according to the Tokyo Times. The characteristics of the actual ice formation that ultimately releases can range from thin dense sheets of hard ice that flutter to the ground to bowling ball-sized chunks of white rigid ice that are less dense but make significantly larger projectiles. These ice formations are largely a result of wind-driven super cooled water droplets from visible cloud formations, fog or mist coming in contact with cold building materials (see Figure 5).
